USAAVLABS TECHNICAL REPORT 65-38

COMPONENT TESTING XV-9A HOT CYCLE RESEARCH AIRCRAFT SUMMARY REPORT

CONTRACT DA 44-177-AMC-877(T)
HUGHES TOOL COMPANY

This report was prepared by the Hughes Tool Company, Aircraft Division, under the provisions of Contract DA 44-177-AMC-877(T) to document service life substantiation of various critical components of the XV-9A aircraft. The test objectives were completed with generally satisfactory results.

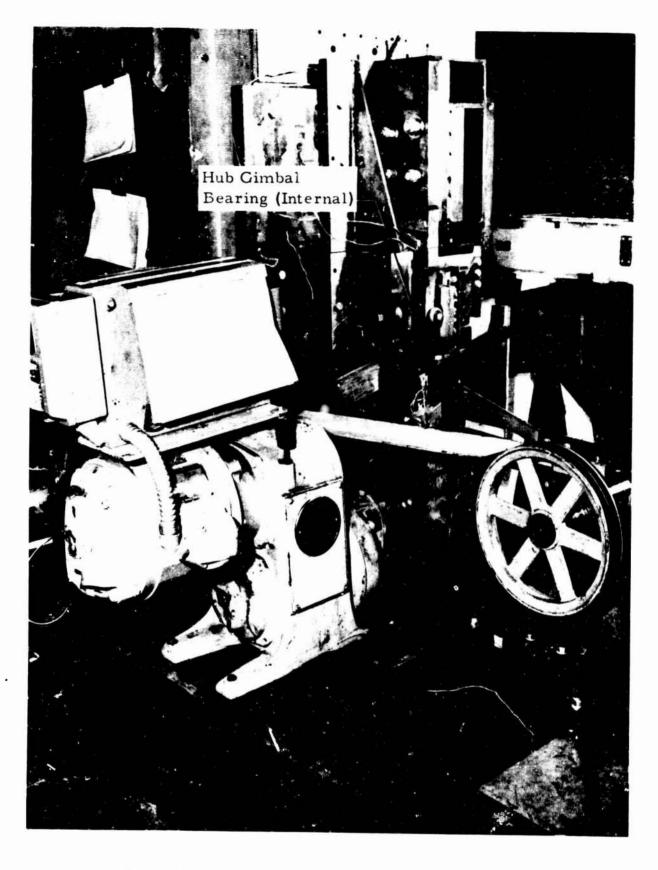
Figure 2. Hub Gimbal System Fatigue Test Setup.

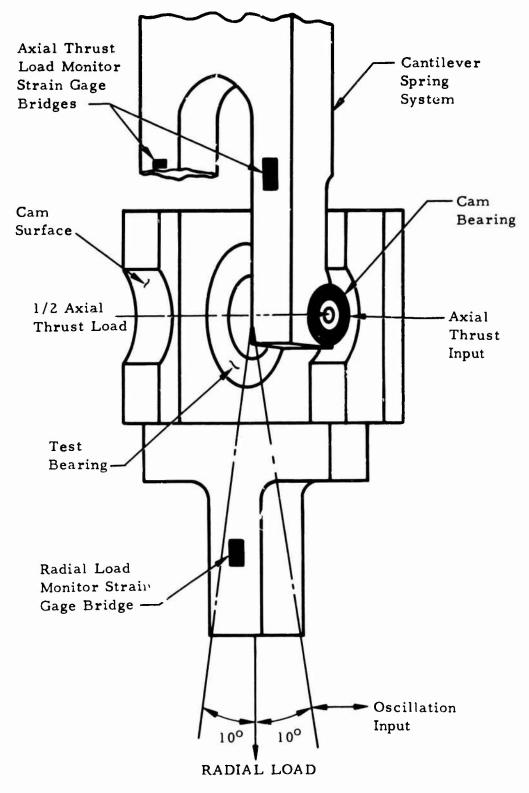
Figure 3. Hub Gimbal System Fatigue Test Loading Schematic.

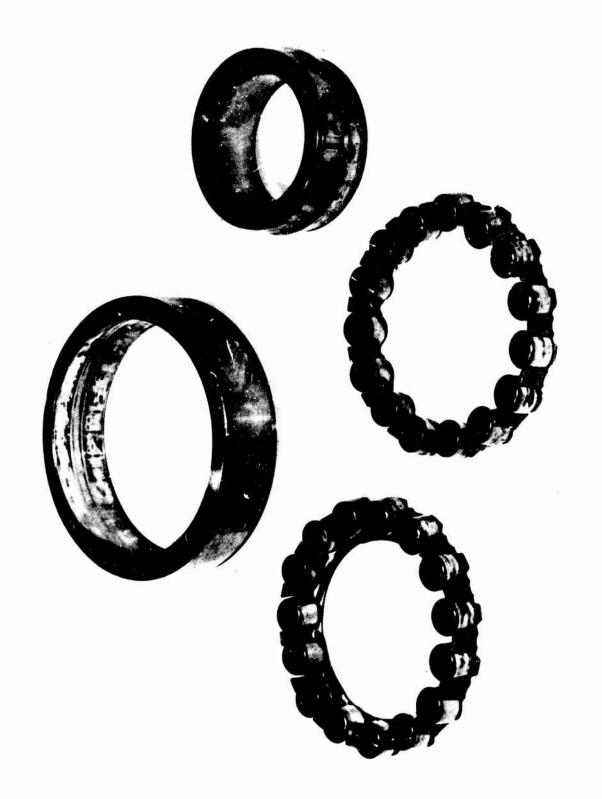
Figures 4 and 5 show the bearing and hub support structure conditions after the endurance test. The bearing was serviceable at the completion of the test.

Figure 4. Hub Gimbal System Bearing After Completion of Test.

- 1. Fifteen rollers showed evidence of fretting (heavily loaded zone).
- 2. Seven rollers revealed slight evidence of fretting (slightly loaded zone).
- 3. Eight rollers showed no evidence of fretting.
- 4. Mating surfaces on the bearing races also indicated areas of fretting.

5. The roller bearing cages showed slight signs of wear due to axial thrust loadings.

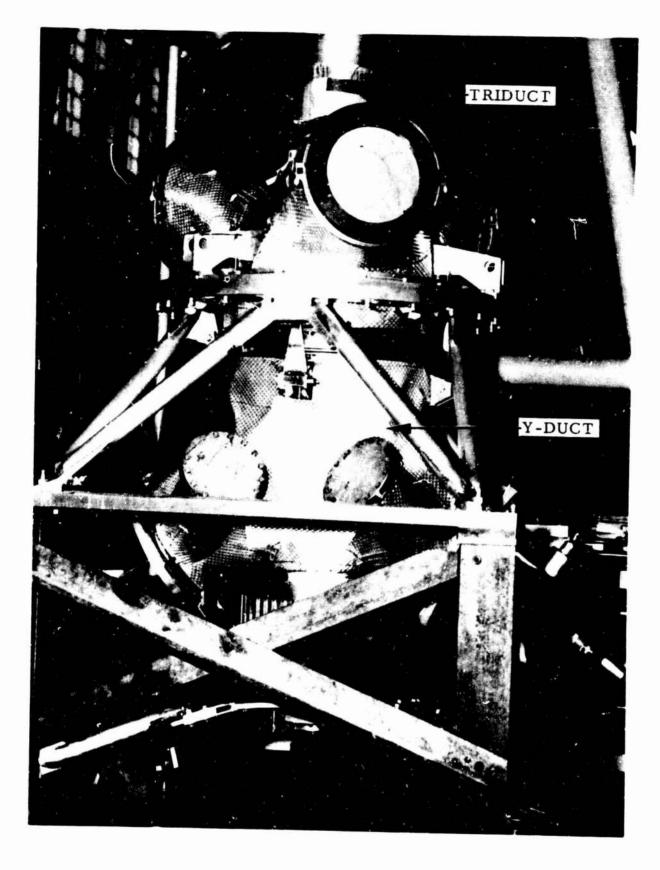
Figure 6. Y-Duct and Triduct Test Setup.

The Y-duct and triduct assemblies were pressurized separately to 36 psig and indicated zero leakage. When pressure of the two ducts was checked, a leakage rate of less than 16 cfm at 26 psig was indicated.

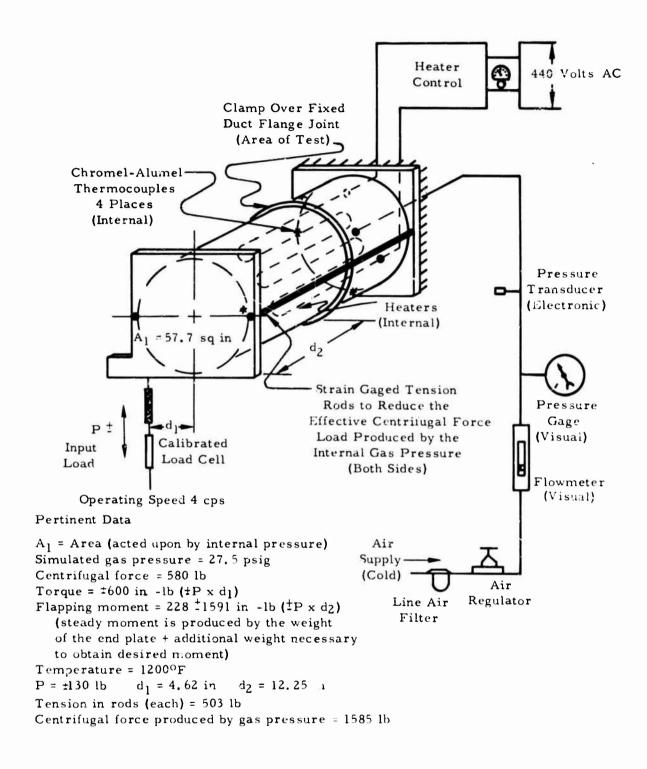
The test specimen was installed in a test fixture to duplicate flapping bending moment, torsion, centrifugal force, hot gas temperatures, and pressure. Shown in Figure 8 is a general schematic indicating the loads applied and instrumentation locations.

Figure 8. Fixed-Duct Joint Seal Test Loading Schematic.

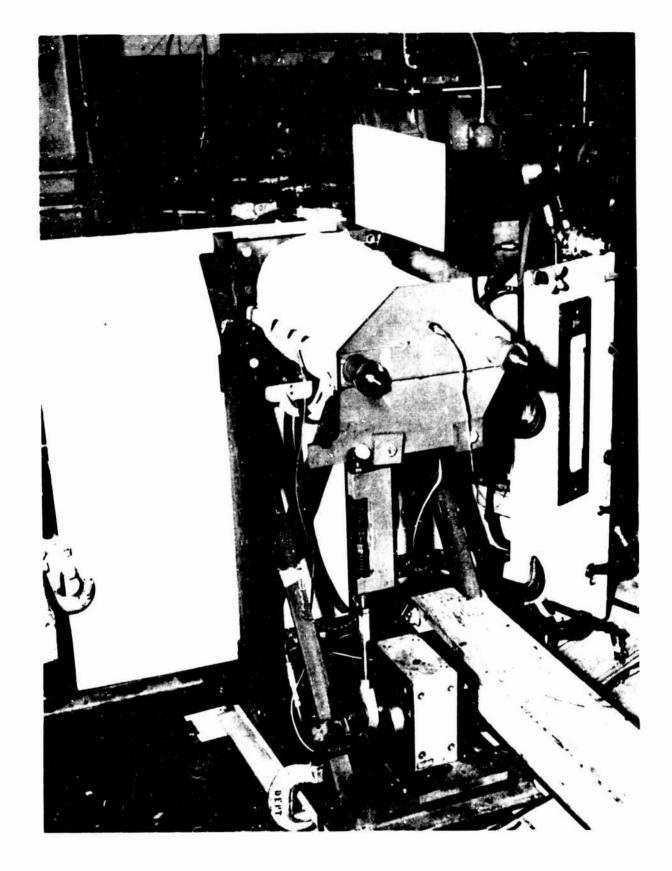
Figure 9. Fixed-Duct Joint Test Setup.

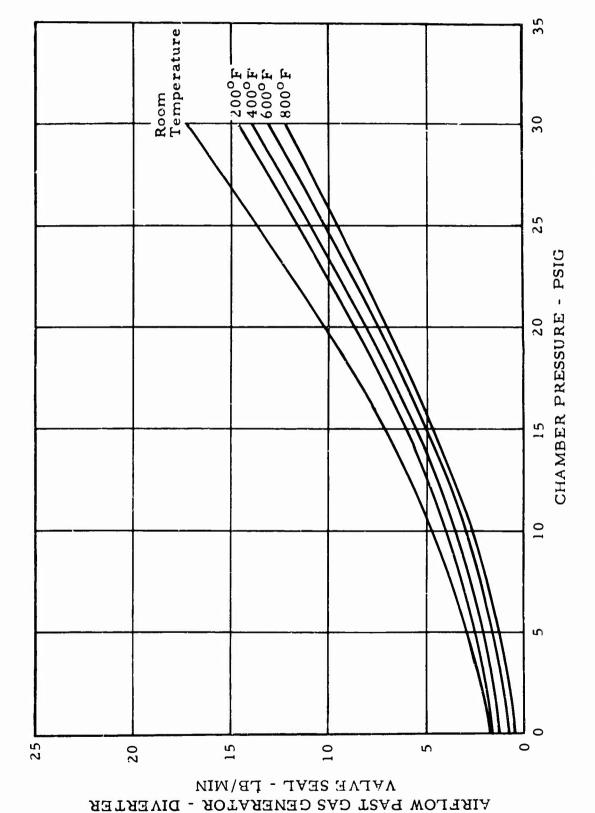
Presented in Figure 12 is a plot of the leakage versus airflow test data at various temperatures. The leakage flow of air past the gas generator-diverter seal was found to be 13 pounds per minute at 800°F and 30 psig. Due to support requirements in the test setup, the center pipe or duct was not allowed to float. This condition resulted in some eccentricity, which was cause for leakage in excess of that anticipated for the aircraft.

Air Mass Flow Past Seal Versus Chamber Pressure and Temperature. Figure 12.

The leakage flow of air past the gas generator-diverter seal was found to be 13 pounds per minute at 800° F and 30 psig. The YT-64 gas generator develops a flow of approximately 1,500 pounds per minute at 26 psig. This leakage by the seal represented a conservative loss of less than 1 percent.

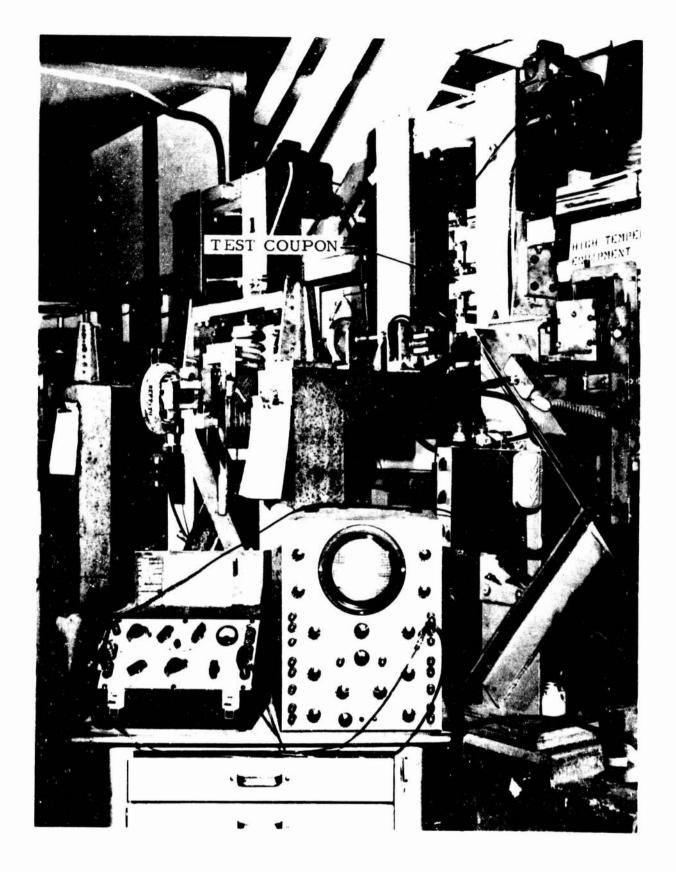
Figure 14. Materials Evaluation - Fatigue Test Setup.

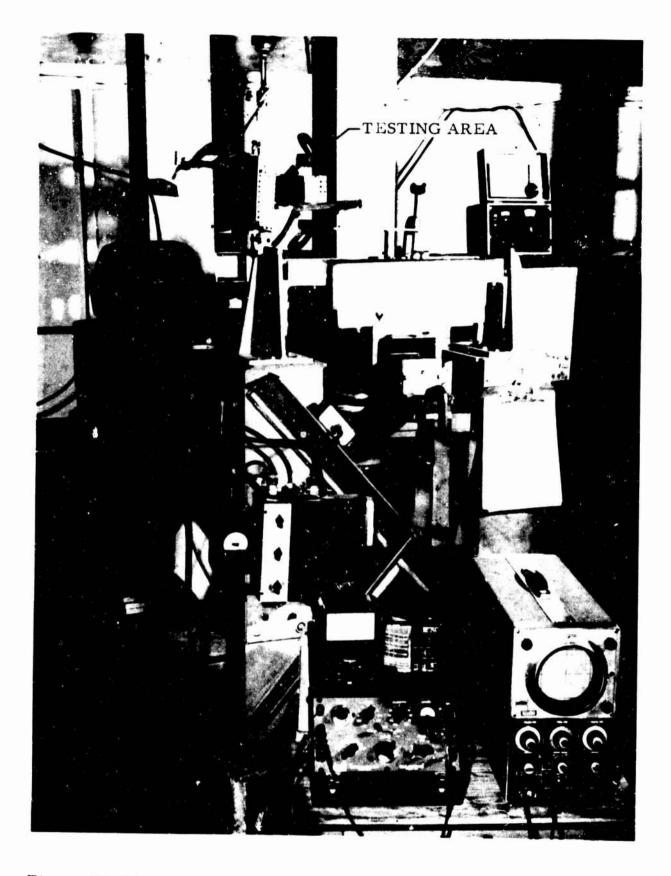
Figure 15. Materials Evaluation - High Temperature Fatigue Test Setup.

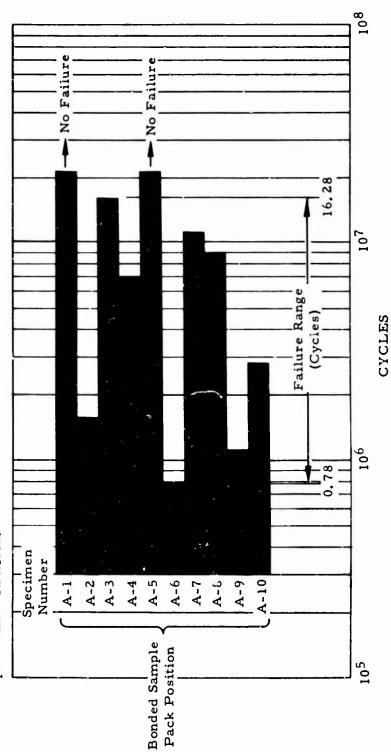
Figure 17. Materials Evaluation - Bonded Sample Failure Bar Graph

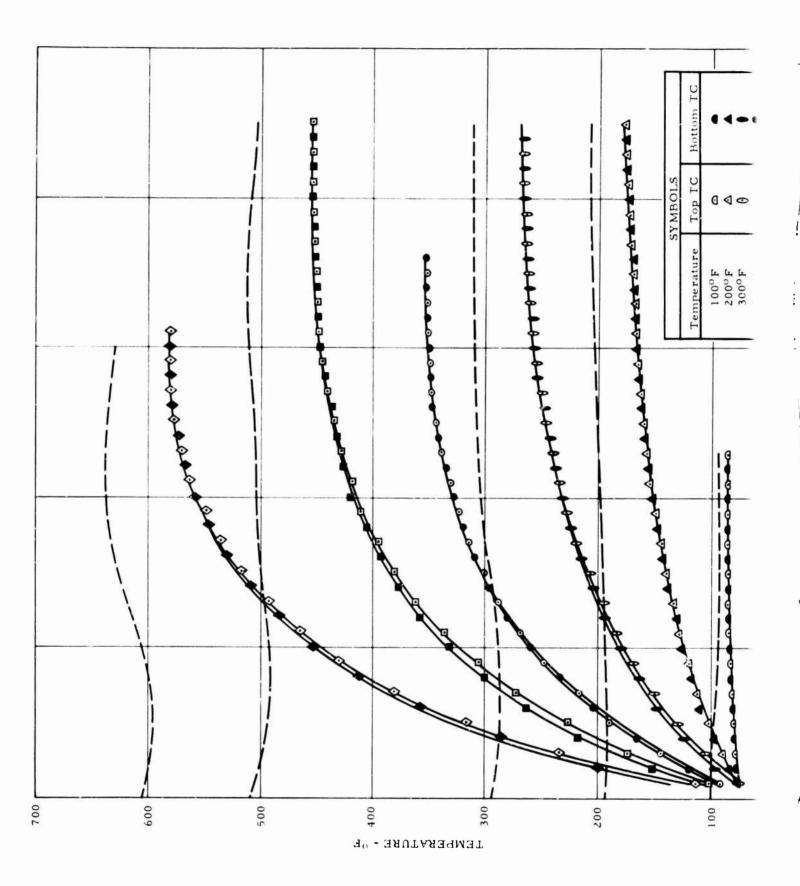
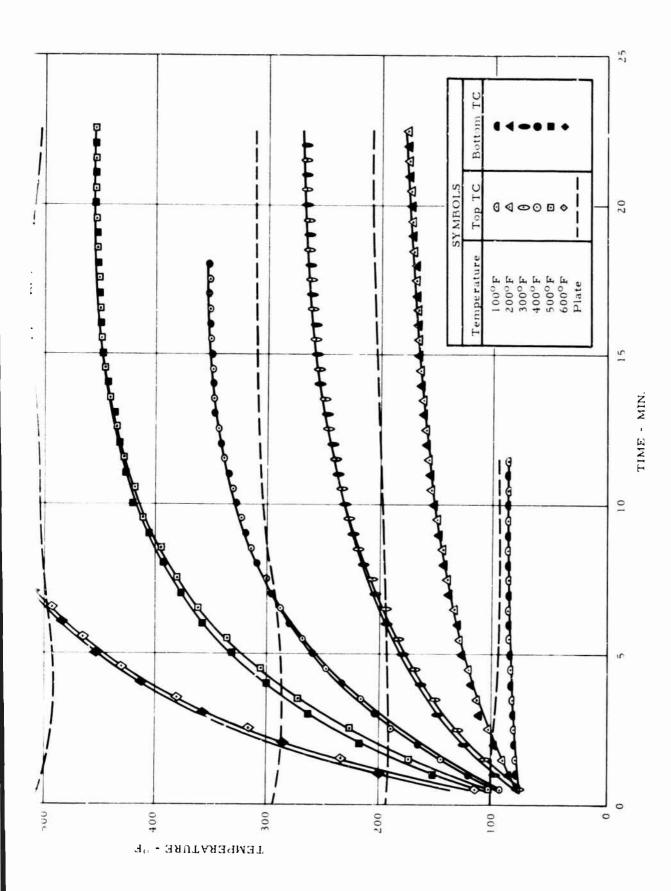
Heat transfer data were recorded, and are presented in time-versustemperature plots for each of the four materials tested. Figures 18 through 21 show these data.

Figure 18. Material Evaluation - Heat Transfer Data - AM 355.

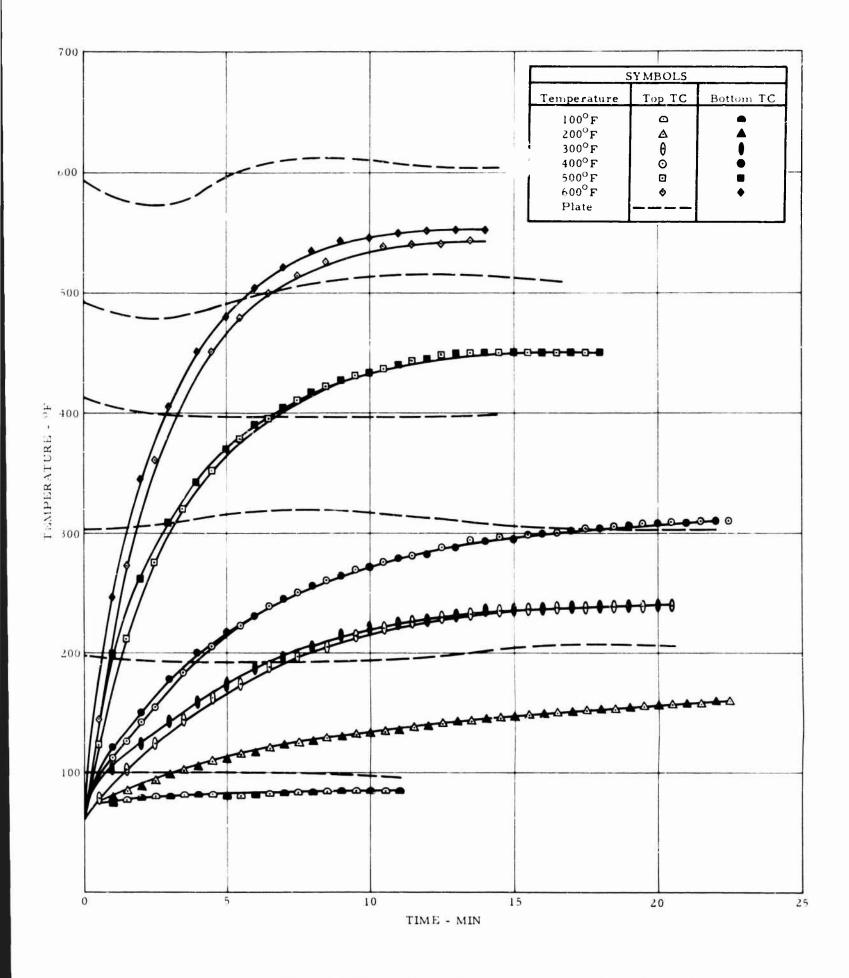
Figure 19. Material Evaluation - Heat Transfer Data - Titanium

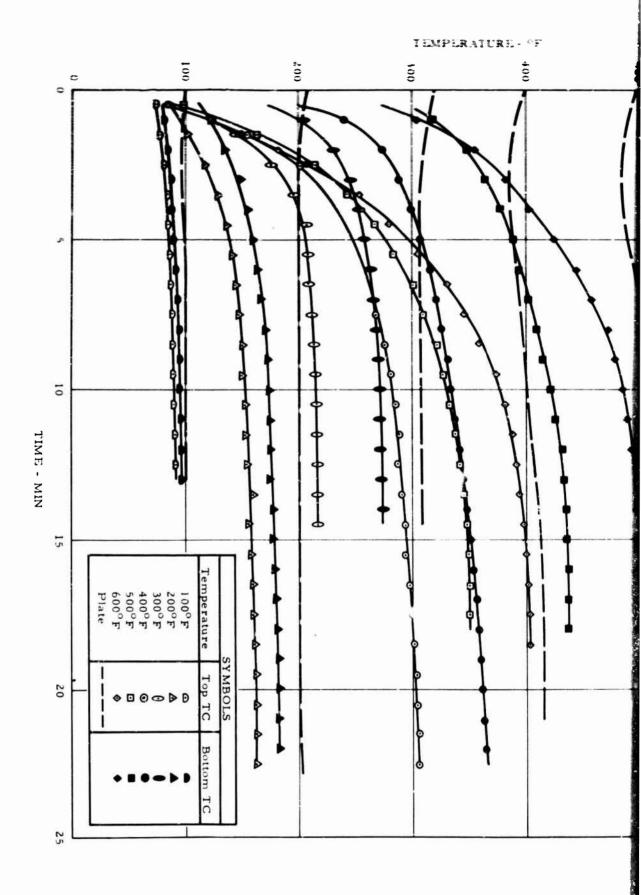
Figure 20. Material Evaluation - Heat Transfer Data - Bonded Specimen.

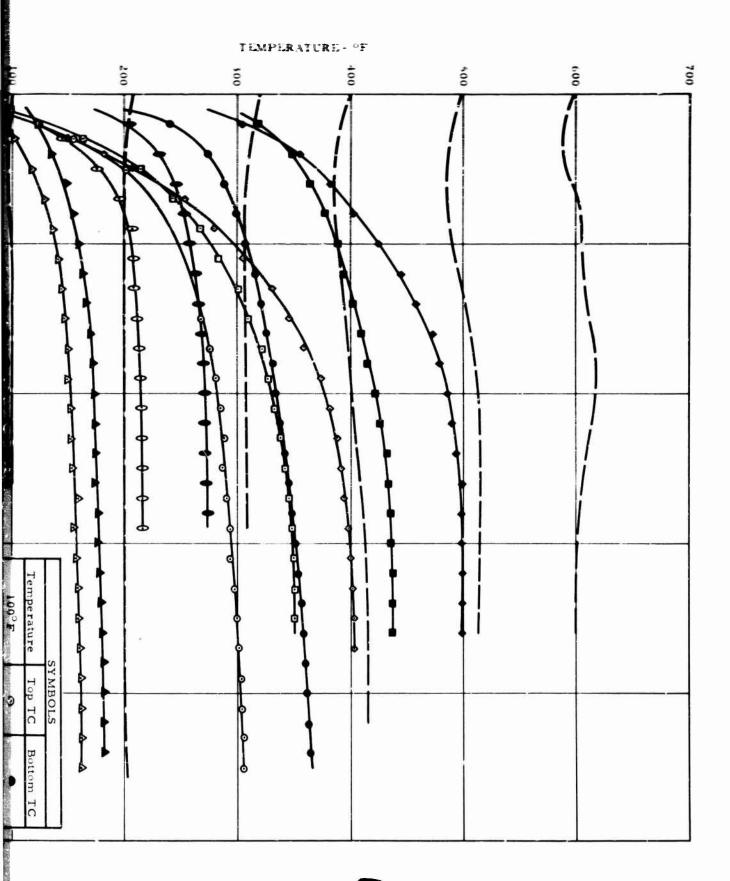
Figure 21. Material Evaluation - Heat Transfer Data Laminated Specimen.

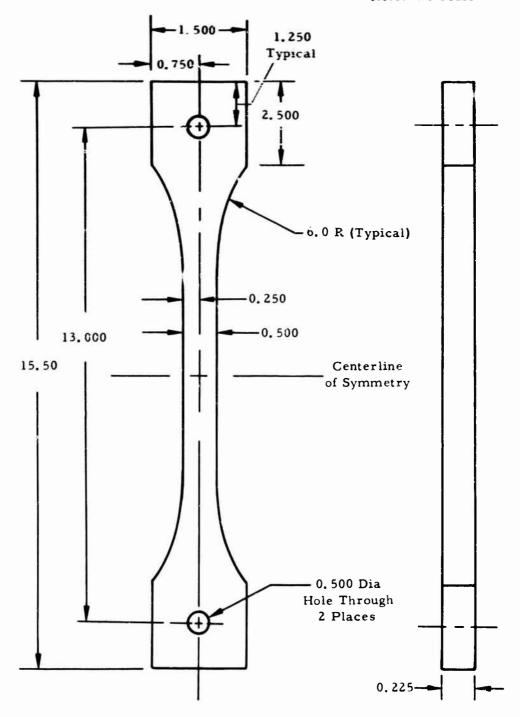
A sketch of the laminated spar section is shown in Figure 22. Shielding consisted of 0.005-in aliron; 0.012-in type 301 stainless steel, duplicating the sheet metal blade segment construction; and 0.010-in teflon-impregnated fiber glass sheet used as an antifretting material.

Material: AM 355 CRT Strip Bonded With Adhesive

Figure 22. Fatigue Test of Spar Material With Hot Gas Impingement - Test Specimen.

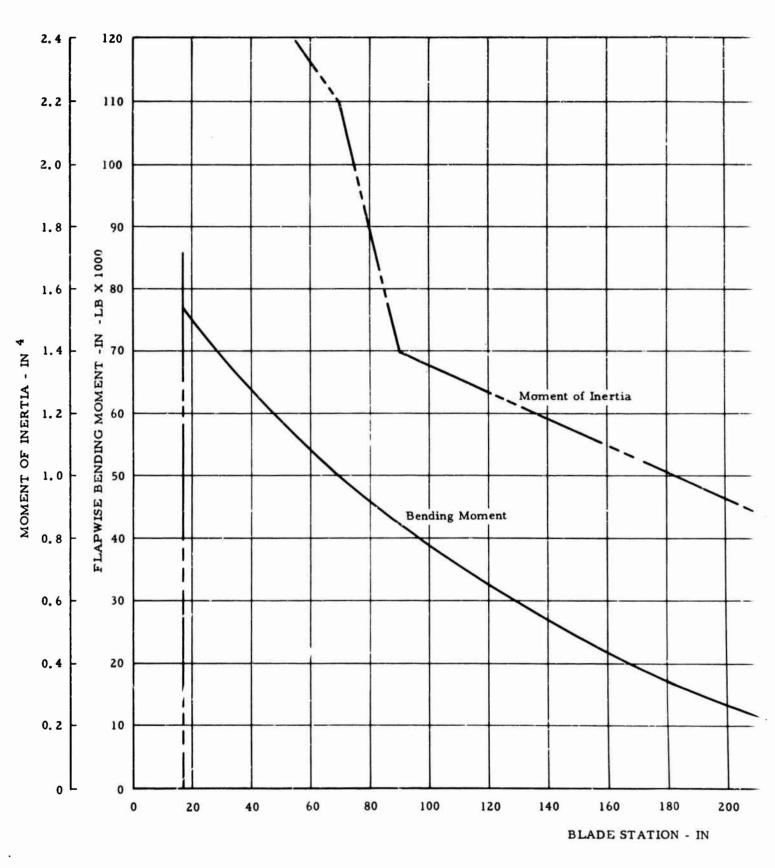
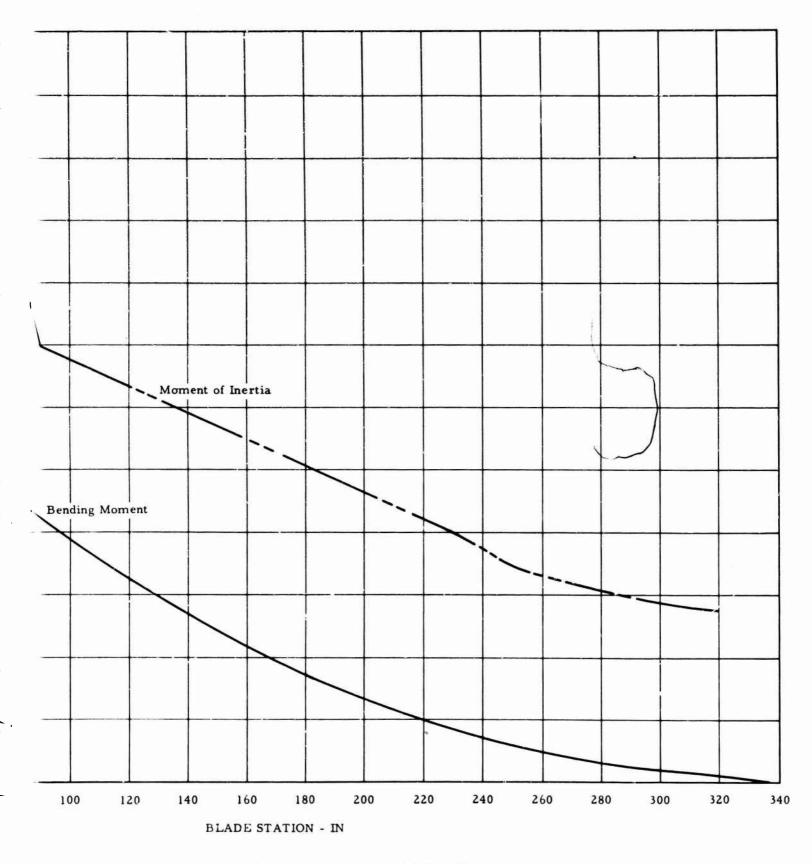
Dial gages were mounted on the front and rear spars and measured the deflections of the spars during each test. Loads were applied in increments in order to observe the deflections of the front and rear spars. Figure 26 shows the bending moment versus blade span for a 1-g load condition. Figure 27 shows the test setup.

Figure 26. Spar Buckling Test - Blade Bending Momeil-g Loading on Blade.

Spar Buckling Test - Blade Bending Moment Distribution - 1-g Loading on Blade.

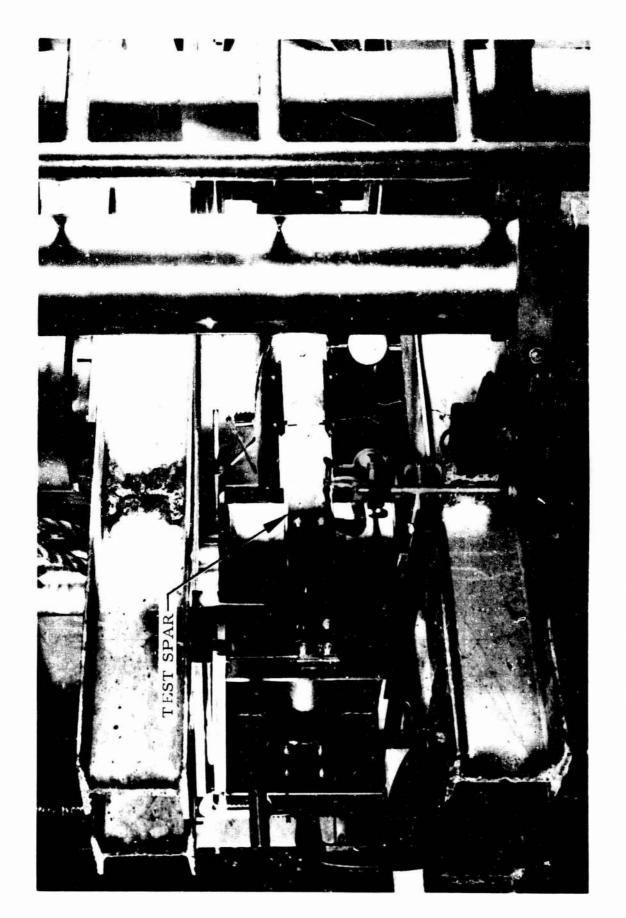
Figure 27. Spar Buckling Test - General Test Setup.

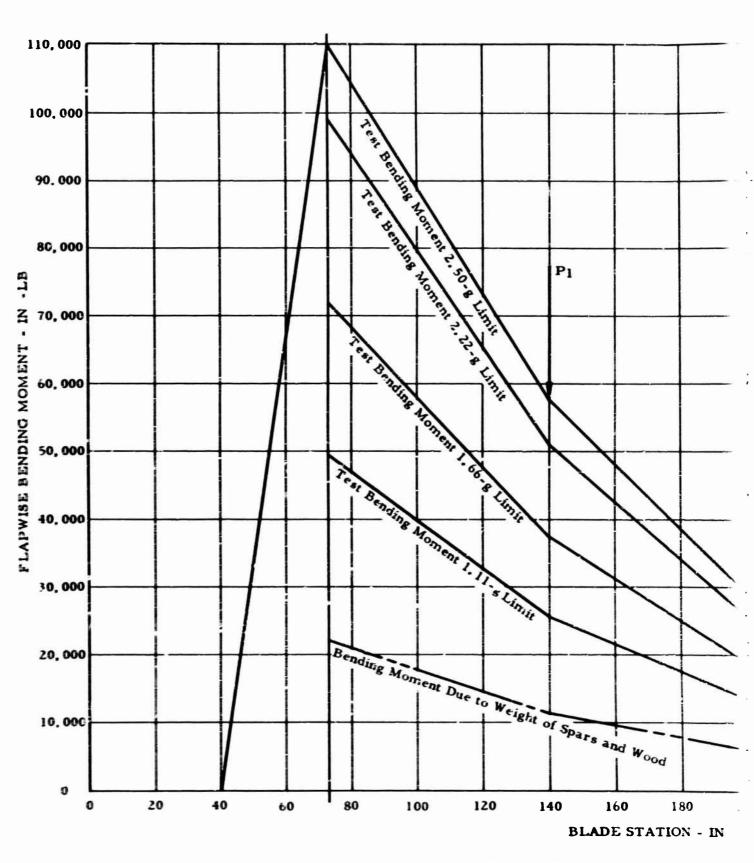
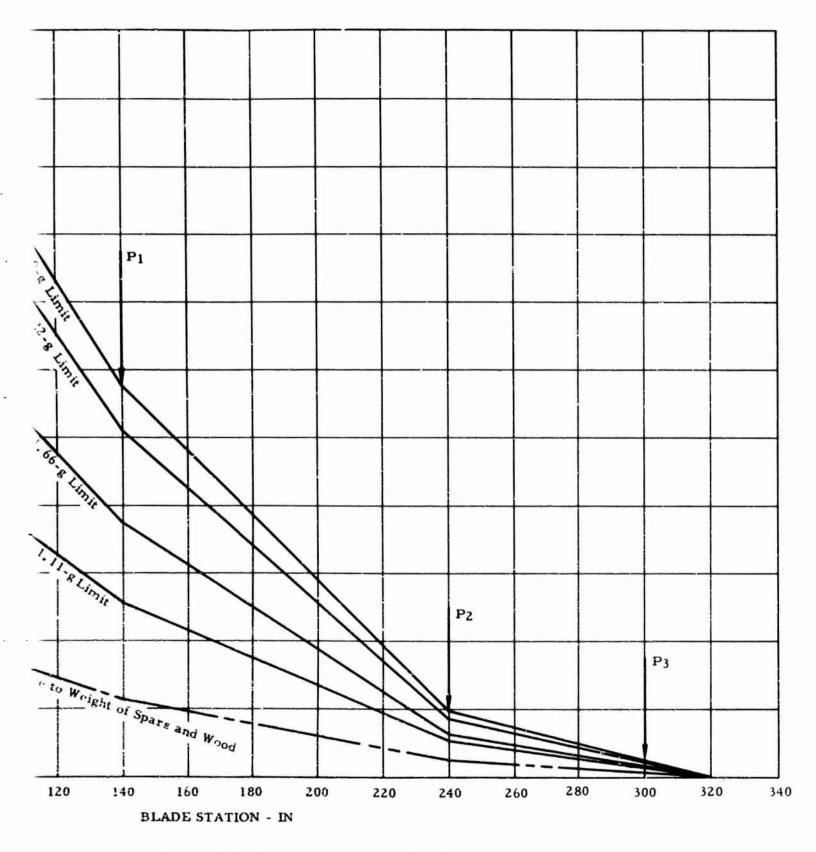
Test loads applied were for a 2.5-g ground flapping condition, shown in Figure 32. The loads were applied at the three stations by means of weight pans and weight bars. Tip deflections were measured at each incremental loading. The setup is shown in Figure 33.

Figure 32. Rotor Blade Spar Proof Test - Bending Moment Distribution.

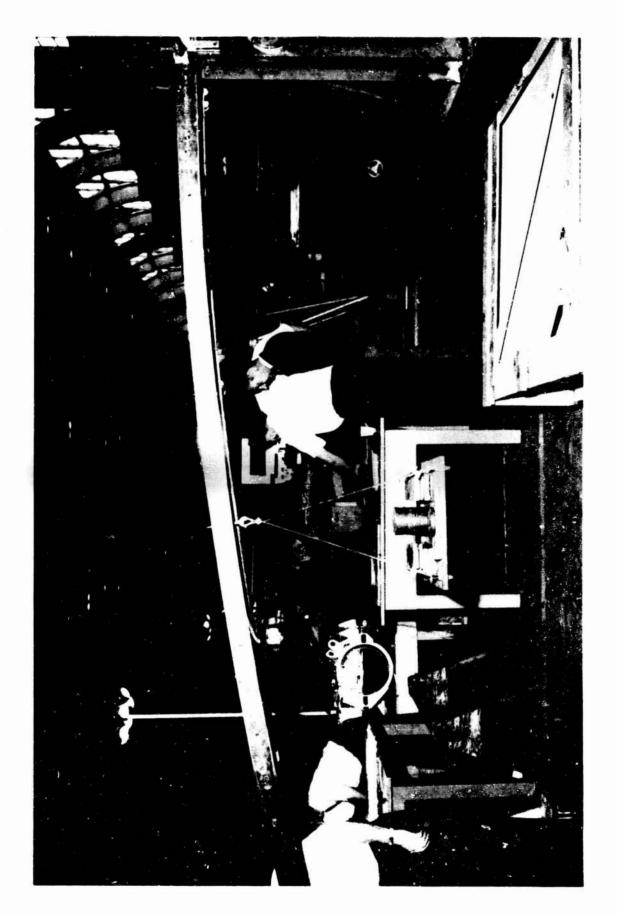
Figure 33. Rotor Blade Spar Proof Test at 2, 5-g Condition.

The bonded rear spar successfully withstood the 2.5-g loading condition. The following table gives the tip deflections recorded.

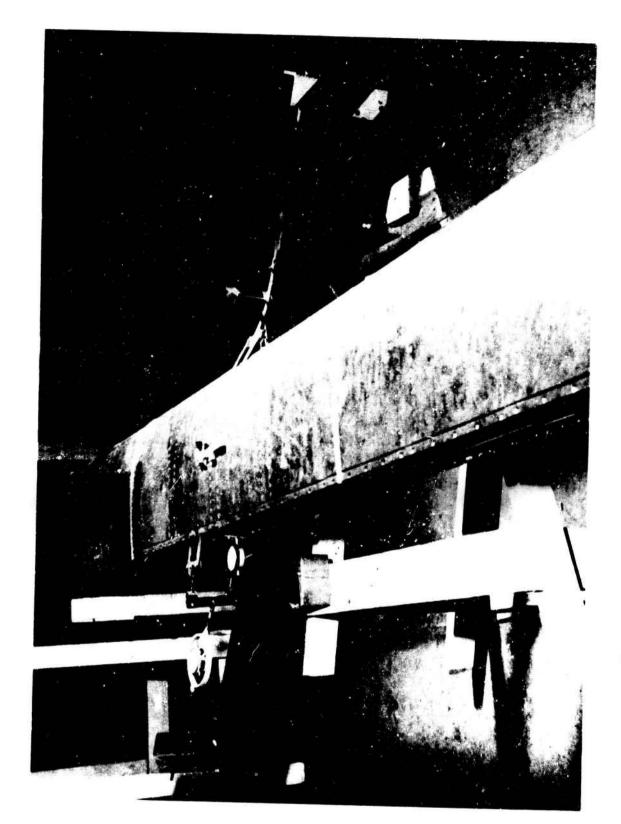
The test setup is shown in Figure 34. A fixture was attached to the existing bolt holes in the skin of a main rotor blade in order to apply a shear load across a representative blade flexure. This specimen was used to obtain preliminary shear distribution information to be incorporated into new spar design studies. Because of the large percentage of shear carried by the flexures, tests utilizing stainless steel spars were not considered.

Figure 34. Rotor Blade Flexure Shear Test Setup.

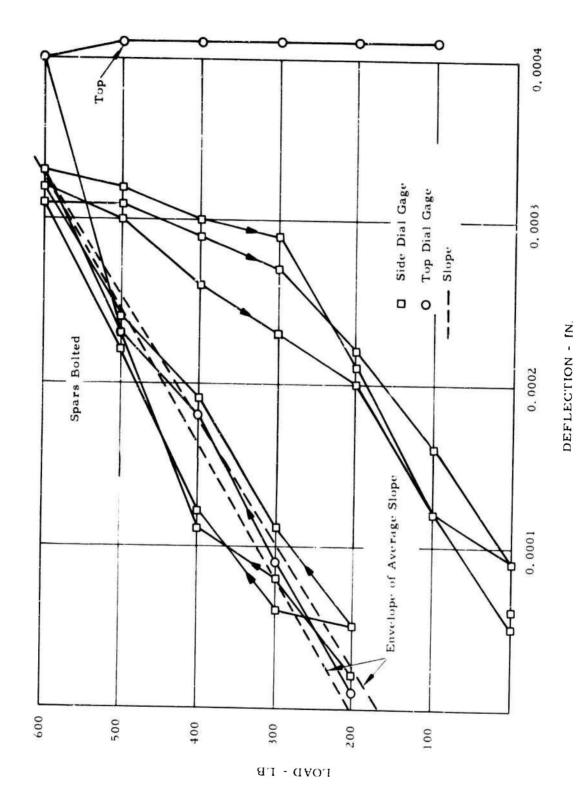
On Figures 35 and 36, load versus deflection curves are plotted for the spars-bolted and spars-unbolted conditions.

Figure 35. Rotor Blade Flexure Deflection Results - Spars Bolted.

Because of the friction hysteresis and high chordwise stiffness in the blade specimen, only an approximate distribution of shear between the spars and the flexures can be determined. The shear carried by the flexure was between 90 and 98.5 percent.

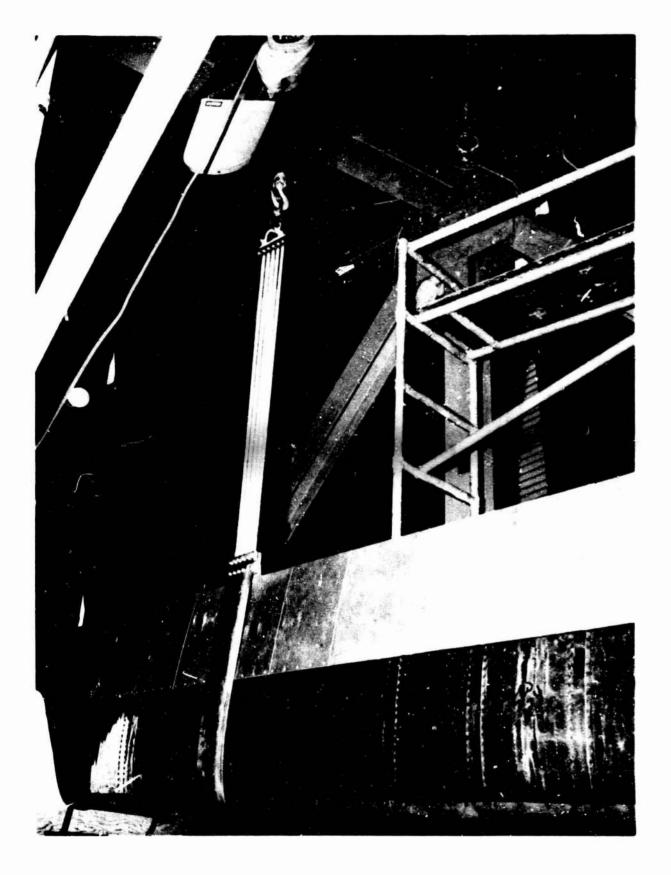
Figure 38. Rotor Blade Shake Test - Bungee Support System.

The bungee support system was later changed to blade station 218 (first mode nodal point), where the natural frequencies were again rechecked and were found to coincide with reported test results.

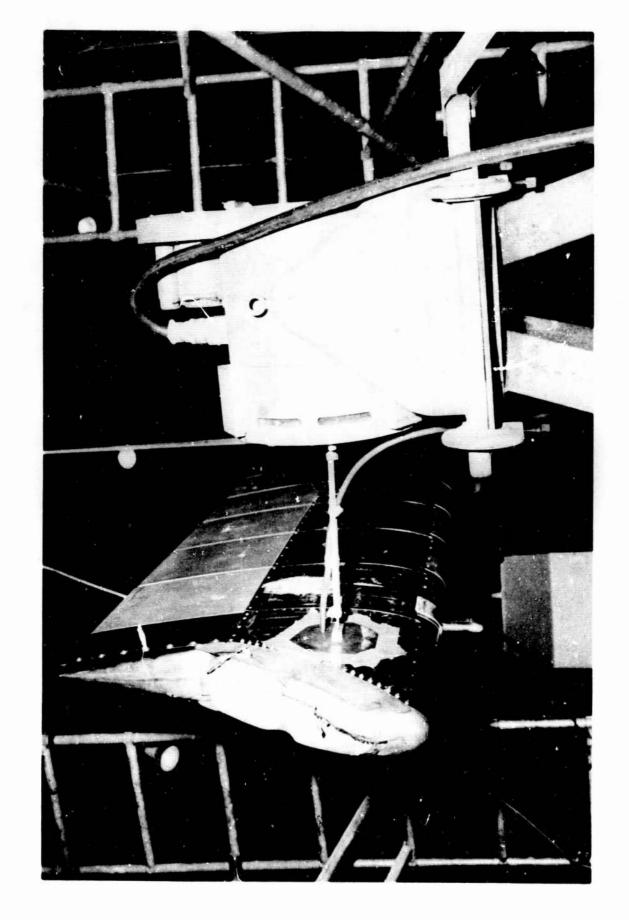
Figure 39. Rotor Blade Shake Test - Shaker Attachment.

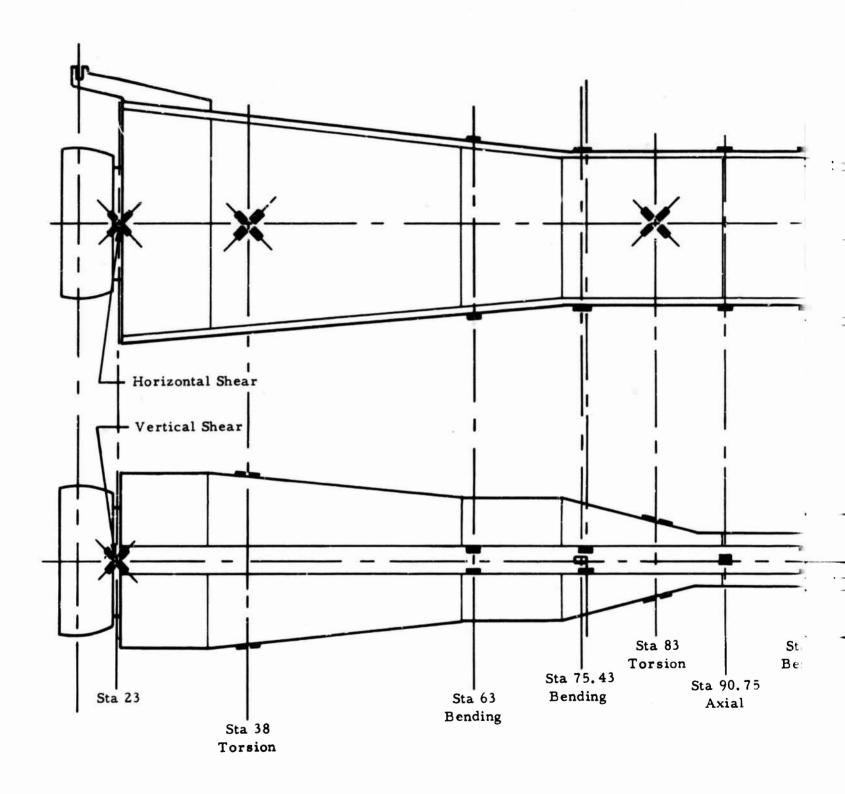
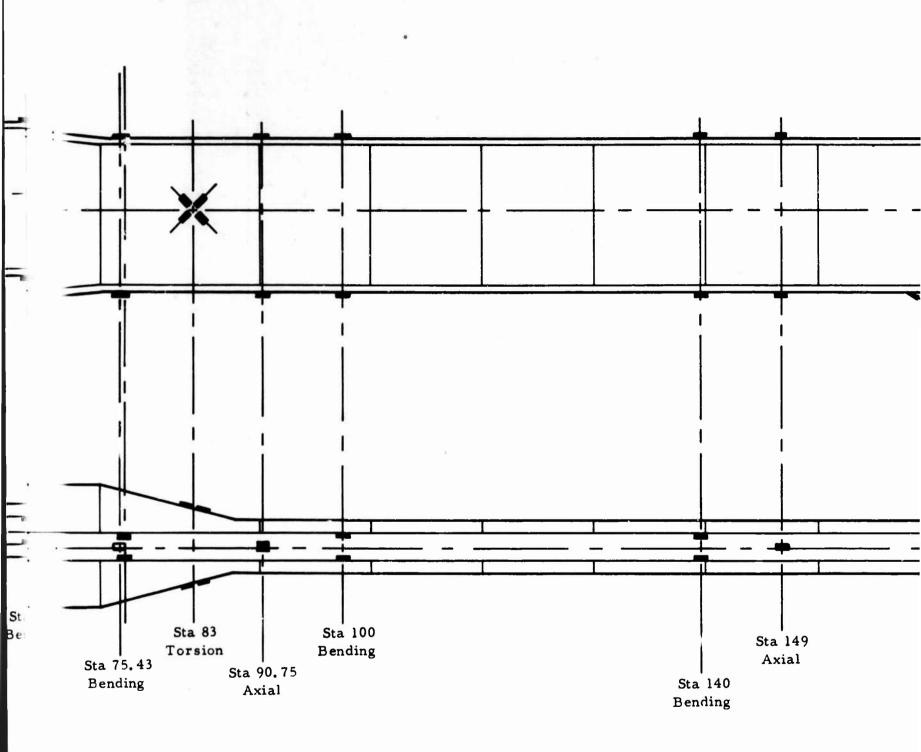
Figure 40. Blade Static Deflection Test - Instrumentation Location.

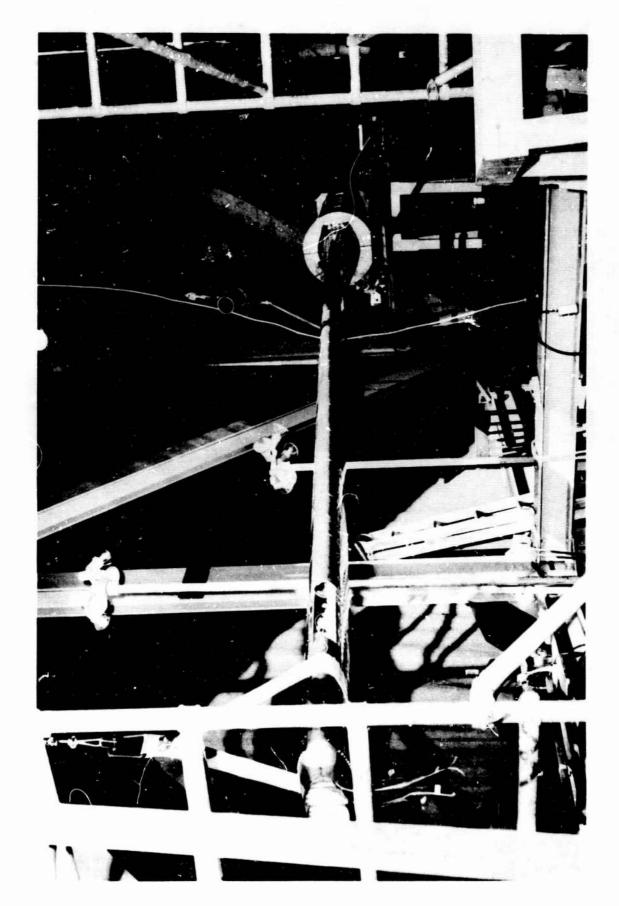
Figure 41. Blade Static Deflection Test - Flapwise Blade Setup.

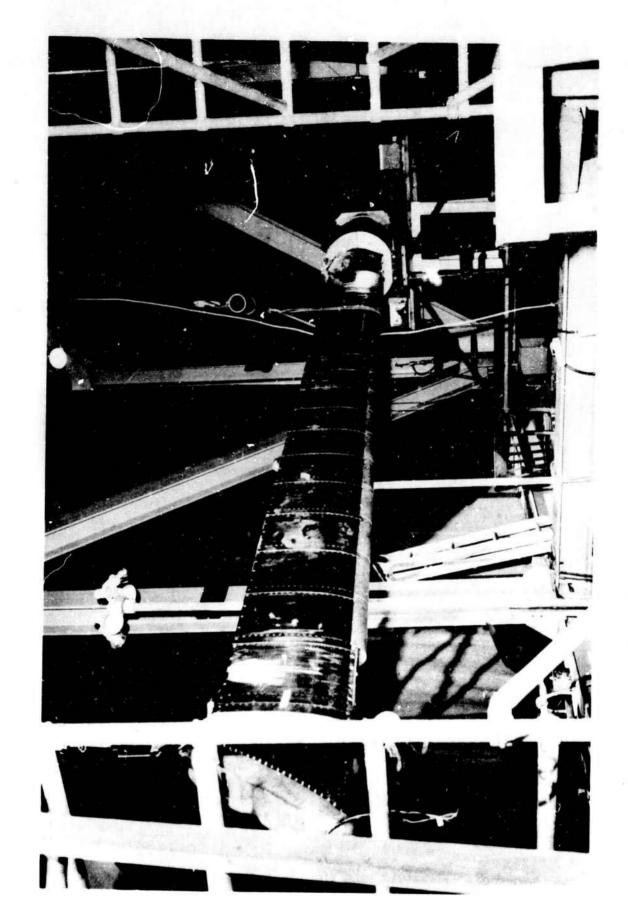
Figure 42. Blade Static Deflection Test - Chordwise Blade Setup.

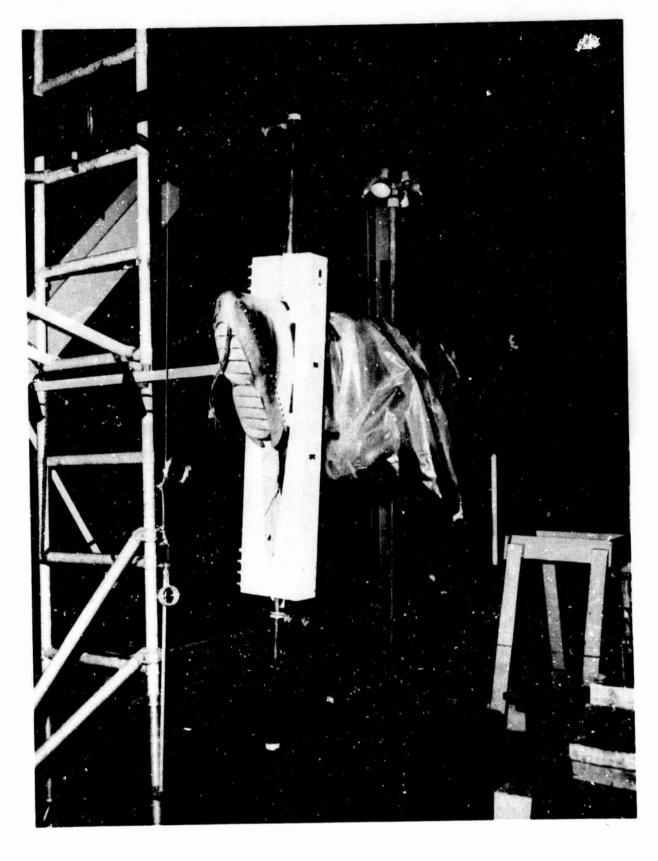
and (3) torsion in clockwise and counterclockwise directions (Figure 43). Simultaneously, while the above tests were being conducted, tip deflections were recorded for the flapwise and chordwise conditions, and angular deflections for the torsion conditions.

Figure 43. Blade Static Deflection Test - Torsion Blade Setup.

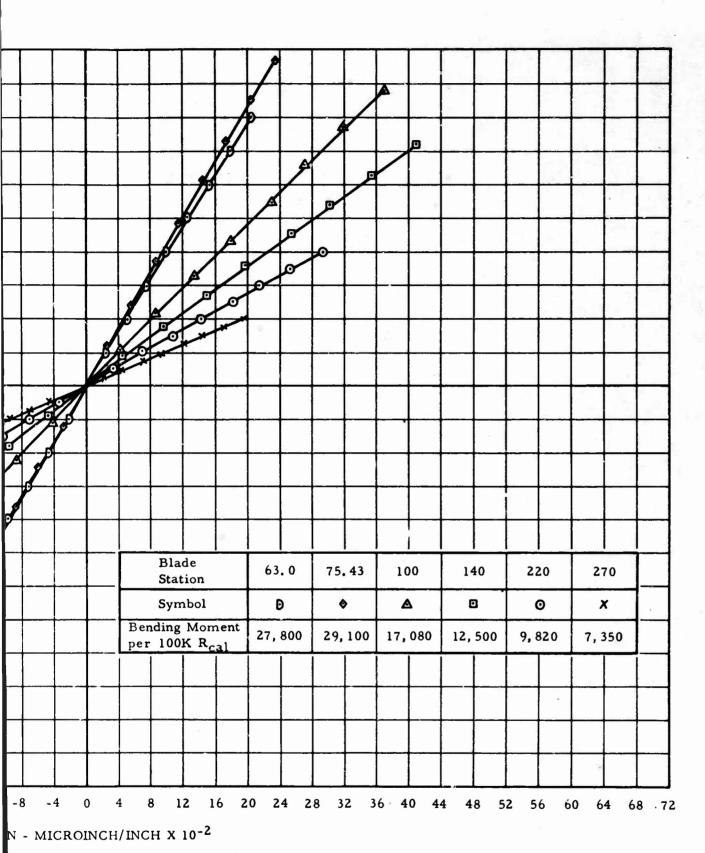
atic Deflection Test - Flapwise Bending, Front Spar.

The calibrations for the flapwise, chordwise, and torsion conditions, shown in Figures 44 through 50, are presented in a plotted form of calibration parameter versus strain output of the bridge.

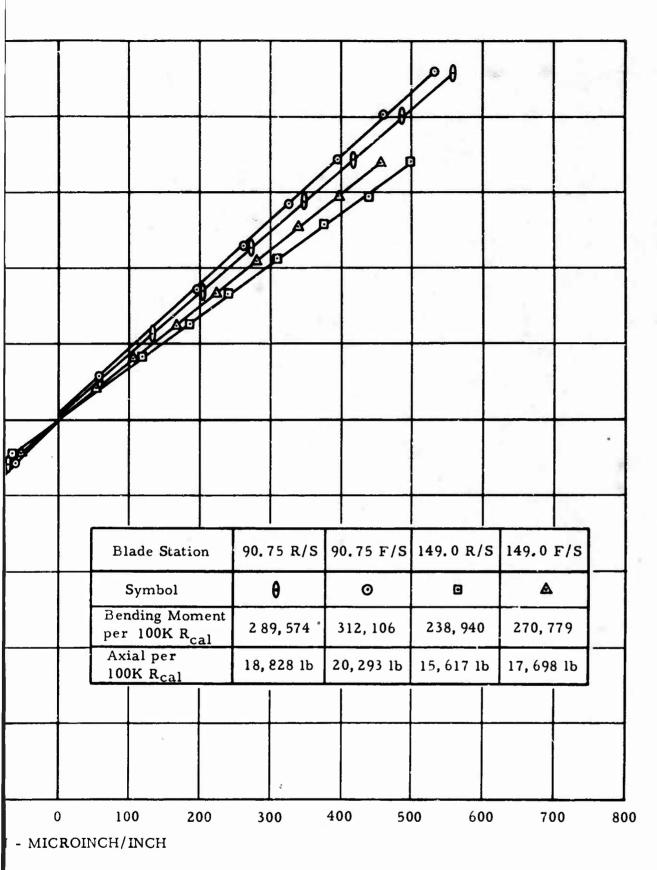
Static Deflection Test - Chordwise Bending.

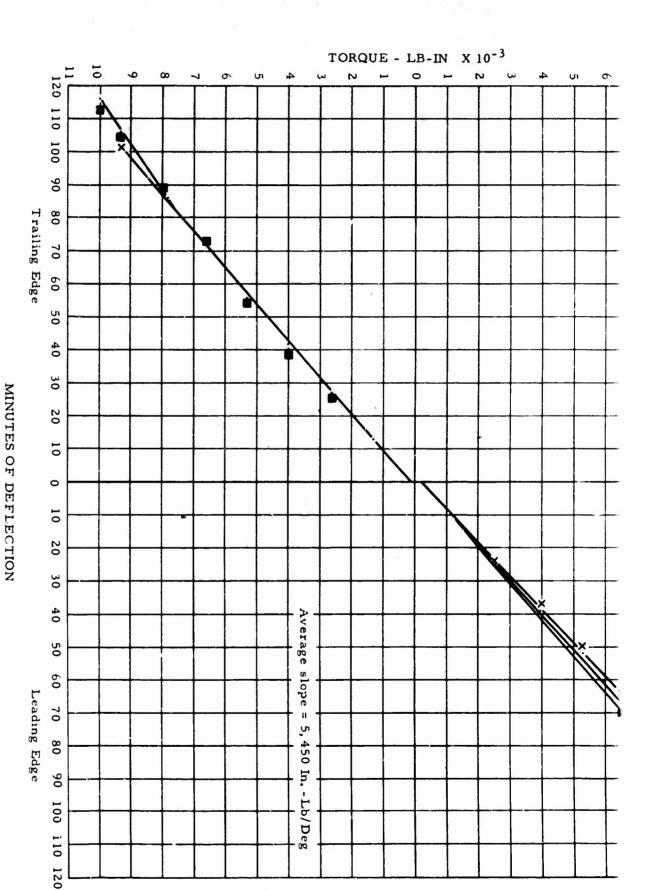
Figure 53. Blade Static Deflection Test - Torsion Deflection at Tip.

Tip deflections for the above conditions are presented in Figures 51 through 53.

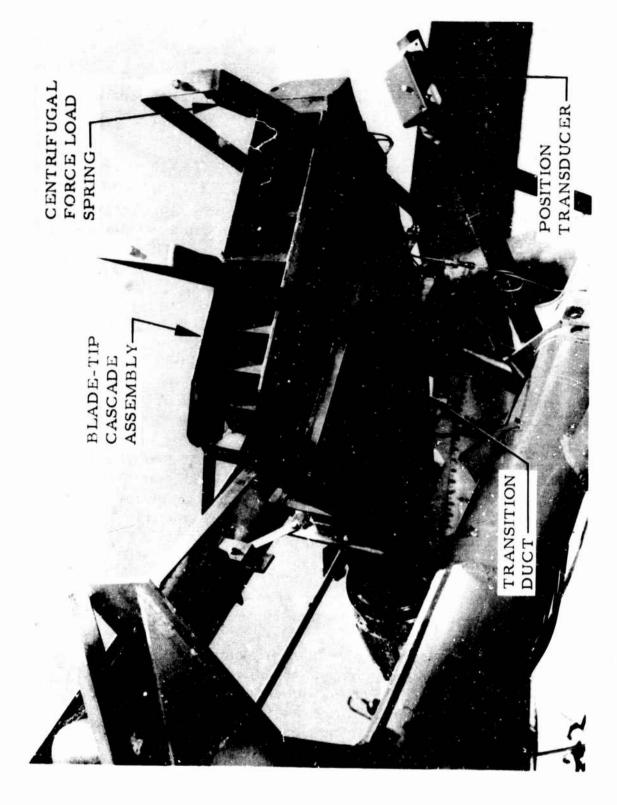
A separate air system for cycling the blade-tip closure valve actuating cylinder was supplied by a pressurized accumulator with a normal operating range of 2800 psig. The instrumentation consisted of a position light indicator to monitor the valve position and a linear potentiometer rigged to the actuating mechanisms with its signal output (indicating valve position) recorded on an oscillograph.

Figure 54. Blade-Tip Closure Valve Functional Test Setup.
